Restoration of Intertec Superbrain QD

written by Sergio Gervasini and Stefania Calcagno for ESOCOP
The European Society for Computer Preservation
<http://www.esocop.org>

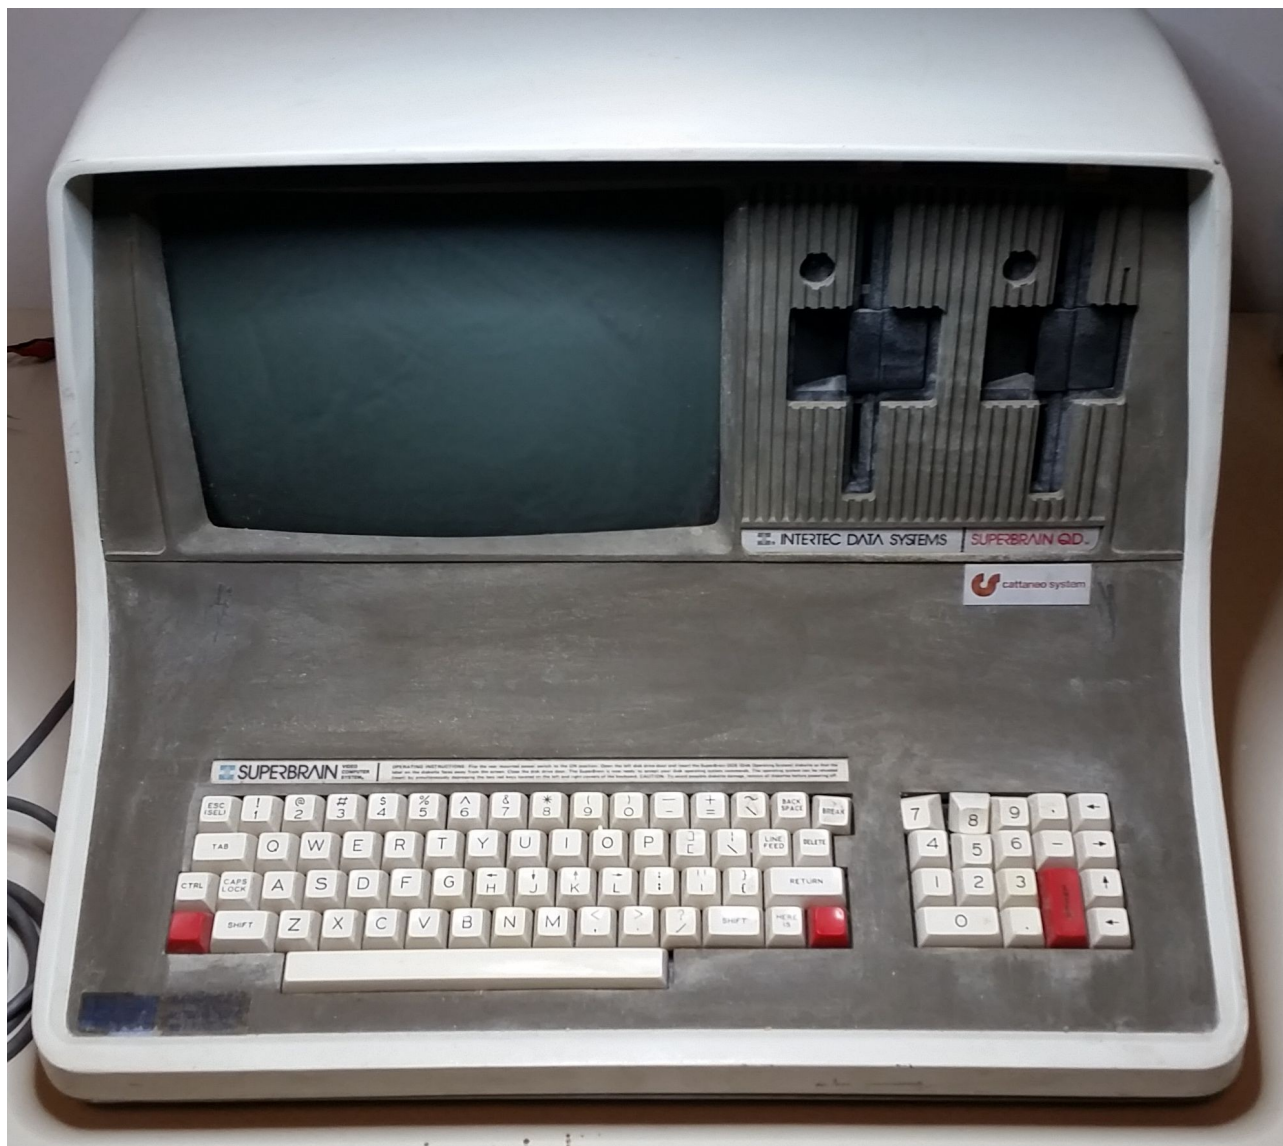
EsoCoP found this machine in a basement in Italy some years ago, the conditions were not very good and for this reason the restoration work was postponed for a long time, until the beginning of 2019 when we started the work.

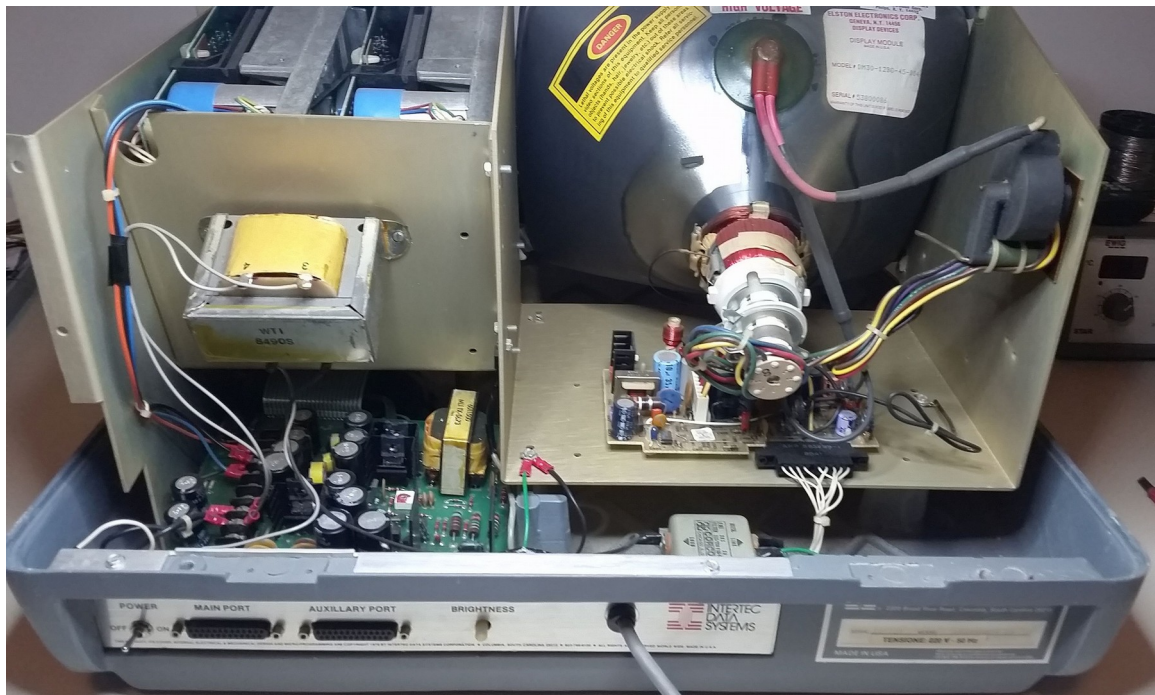
Interesting the location of a transformer behind the floppy disk to reduce the main supply from 220v (European standard) to 110v (USA standard):

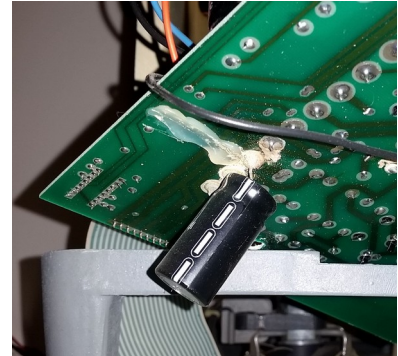
Behind the power supply board we discovered a capacitor with signs of oxidation at the welds, so we disassembled it and carefully cleaned the printed circuit board.

We dismantled the board and its cabling, in order to be able to test the power supply circuits independently.

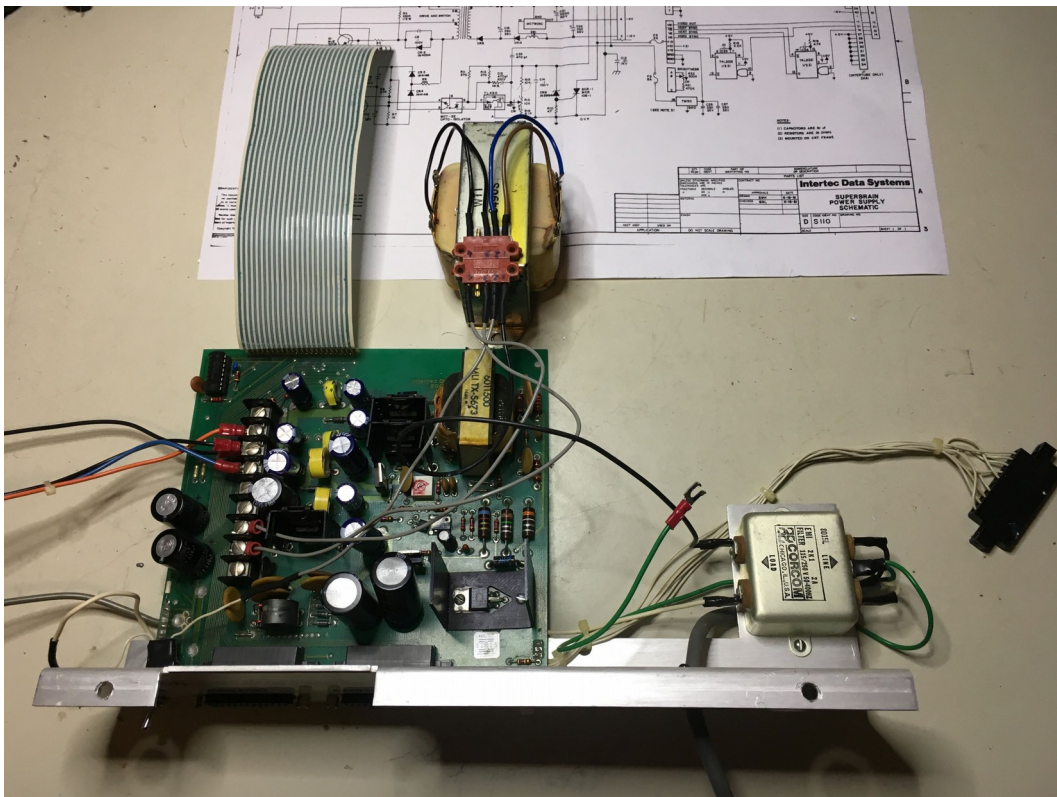
To easily work on the system we also added a connector between the 220v-110v transformer and the board.

Some capacitors were surely broken, we decided to change every capacitor without losing time to check for faulty ones. The power supply started to work fine. We had been able to make some test under load and everything was working as expected.

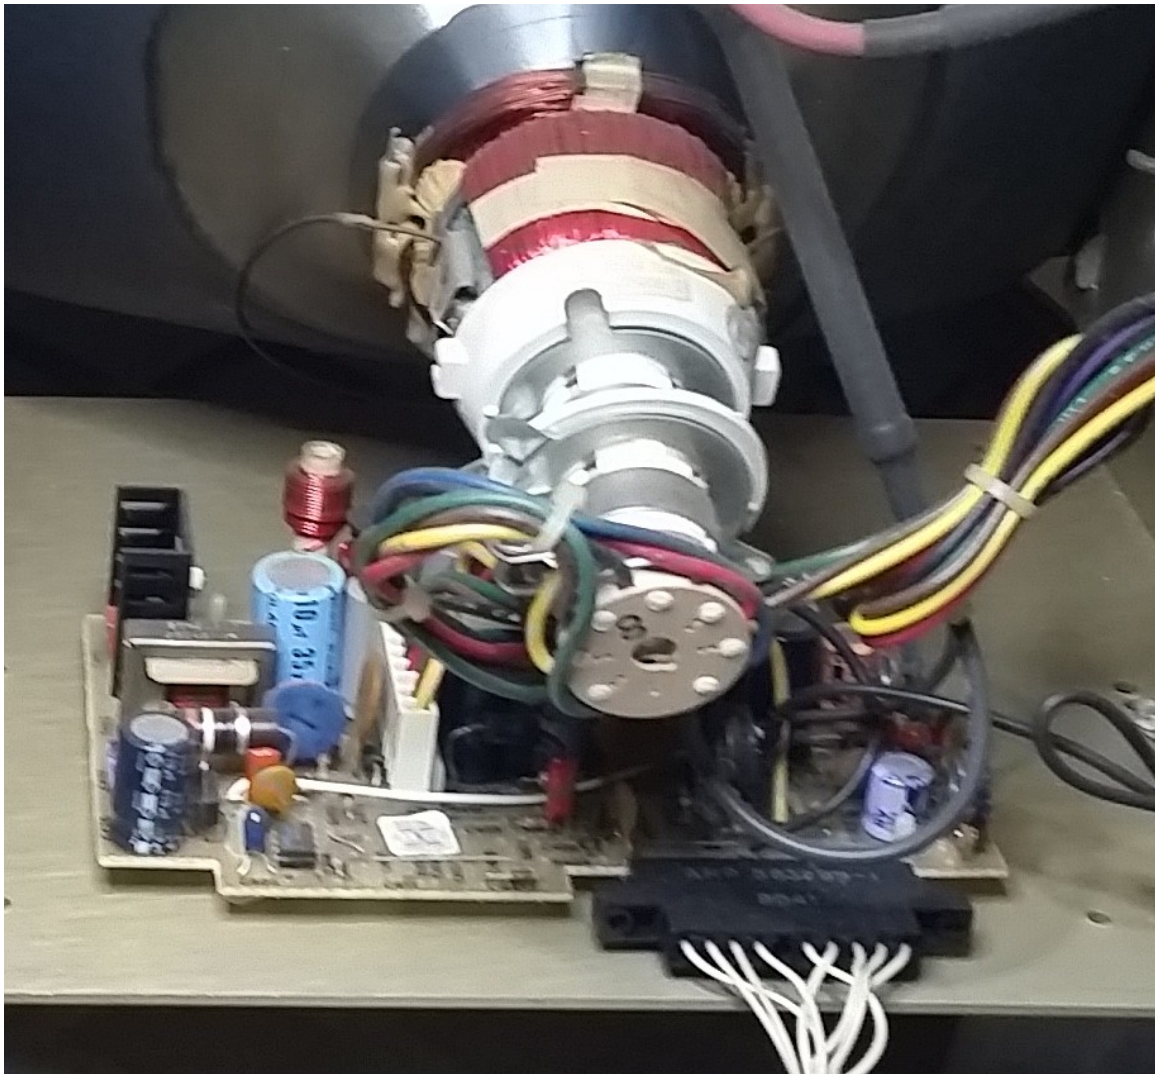
As we finished with the power supply we did connect the monitor to check if it was operational, but a capacitor was in short circuit and it did not let the circuit turn on.

It was the "usual" tantalum capacitor. We did change it and suddenly the monitor started working.

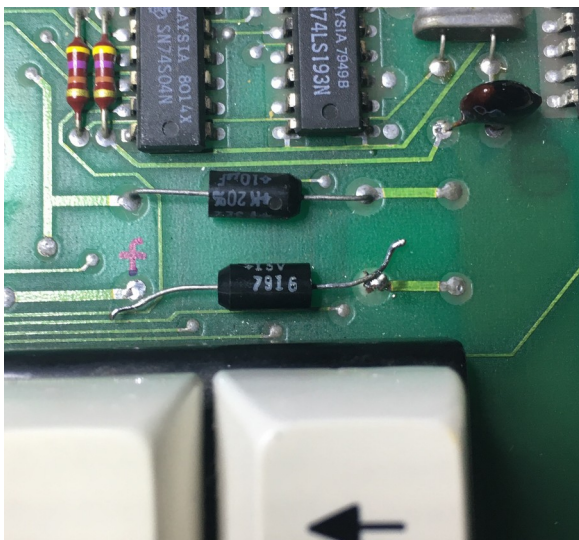
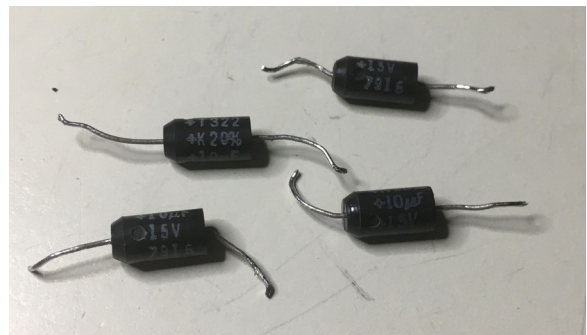
We did check the mainboard to see if there were problems as we discovered on the monitor board before connecting the board itself. We did find short circuits in the +12v line.

Schematics did not help us to understand which of the capacitors were connected to the +12v line, that's why we located and dismantled one by one every capacitor until we got the guilty.

We changed the capacitor and connected the board but, after a few seconds since we gave power to the board, it turned off again.

Another capacitor on the same line went in short circuit. In order to avoid any more problems we did replace all of them.

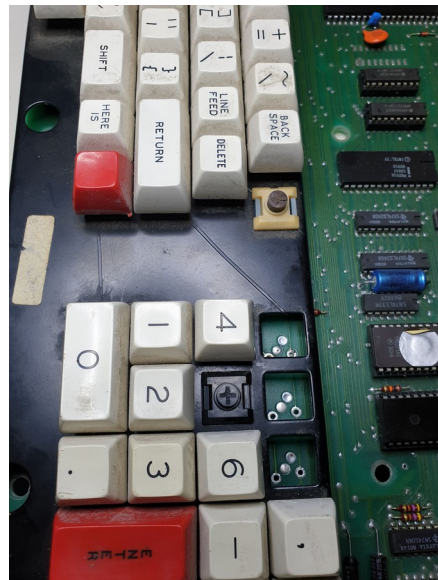
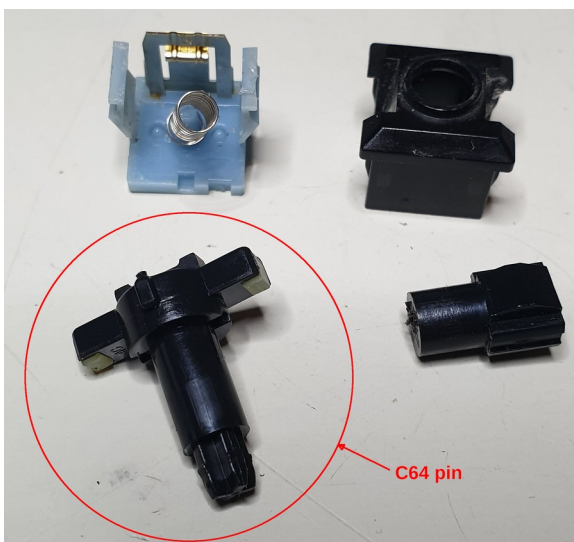
5 keys of the keyboard had their pins broken and it wasn't that easy nor to find spares neither to fix them.

We did dismantle the keyboard, which was produced by Maxi-Switch and used keys originally made by SMK. It's not clear if Maxi-Switch and SMK were somehow connected, but except the "Maxi" or "SMK" logo on the back, the keys are exactly the same.

The top of the pin, where the keycap connects to the pin, has got a usual shape. Between the various keyboard spares we have in our availability we discovered it is really similar to the Commodore 64 pins. Everything else is quite different, the behaviour it's completely different indeed.

We discovered that we could have tried a merge between the two pins, exploiting the original pins base and implanting the C64 pin top, which have the same diameter.

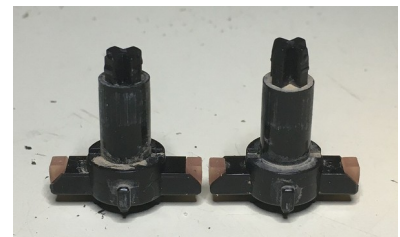
Pay attention: the C64 pins aren't always the same, the cross in some keys is shorter. Only the longest have to be used.

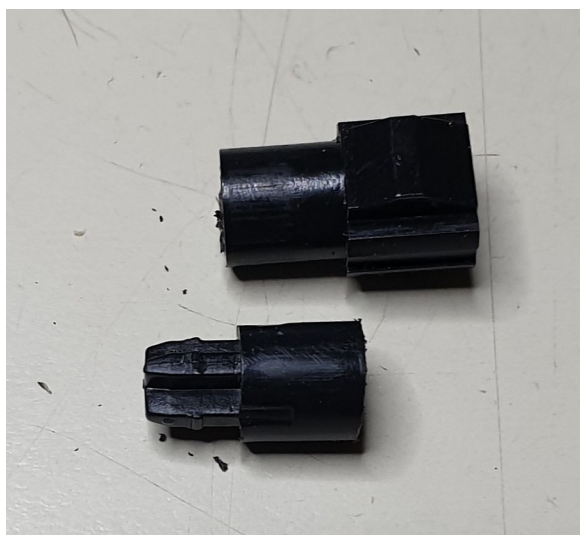
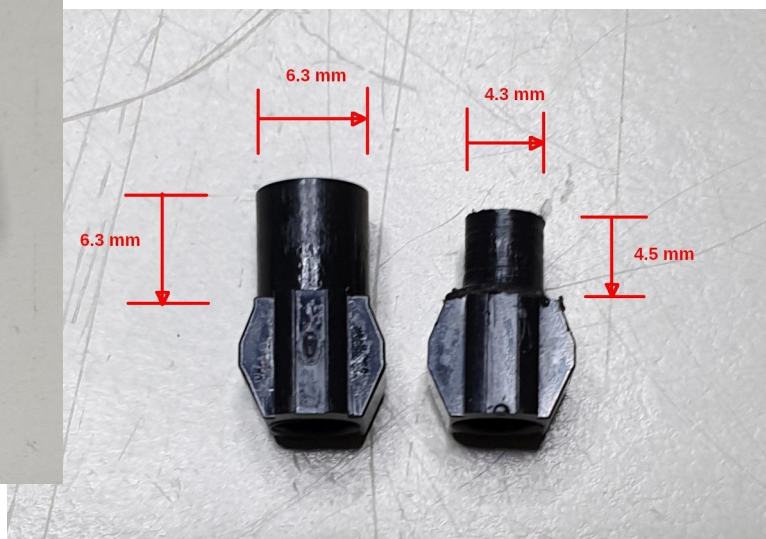
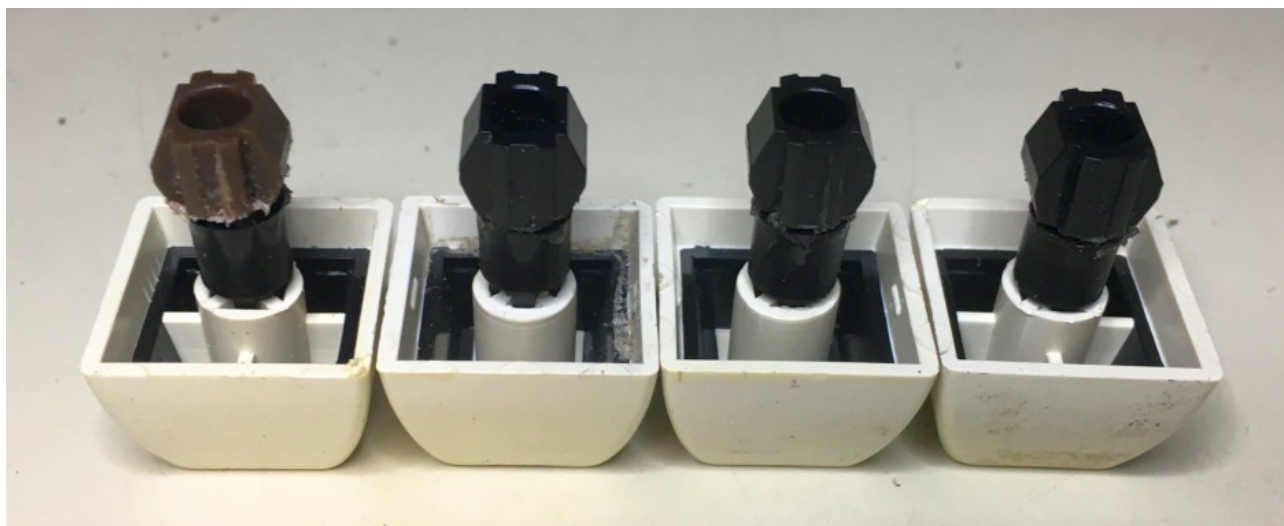
We cut C64 pins to the Maxi-Switch size which we reduced by diameter and shortened. In this way we had been able to perfectly implant the two parts, in order to maintain the same mechanical rigidity and verticality of the pin.

Afterwards we used a bit of glue to attach the two parts.

Just be careful to perfectly align the cross to the keycap and the goal is achieved!

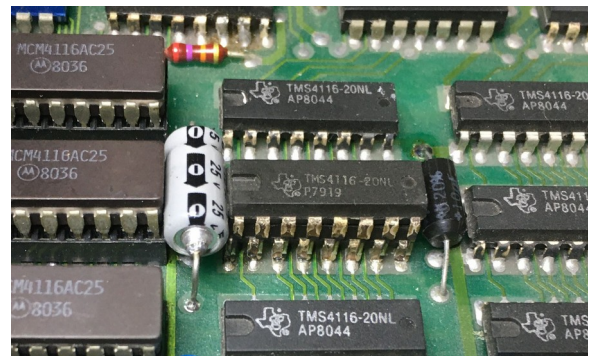
On the mainboard the first 2 banks chips are soldered and this make the work a bit tricky, that's why we did another test before starting to unsold it: the piggyback of a memory chip, to achieve another confirmation.

With the piggybacked chip we started another memory test and it went fine, without errors.

We did solve the problem replacing the faulty ram chip.

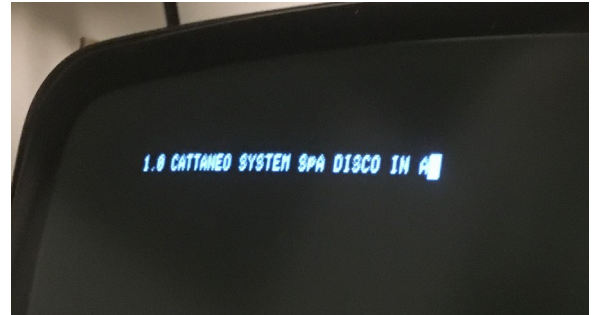
The original BIOS of the machine had been changed with a custom one, customized with the name of the Italian dealer (Cattaneo System SpA), the same name which appears on the case just below the Superbrain label.

We decided to replace it with the last original release we found on the net. We did create an appropriate socket adapter to be filled with a 2716 eprom.

The BIOS worked fine and we also achieved a faster floppy disk access speed.

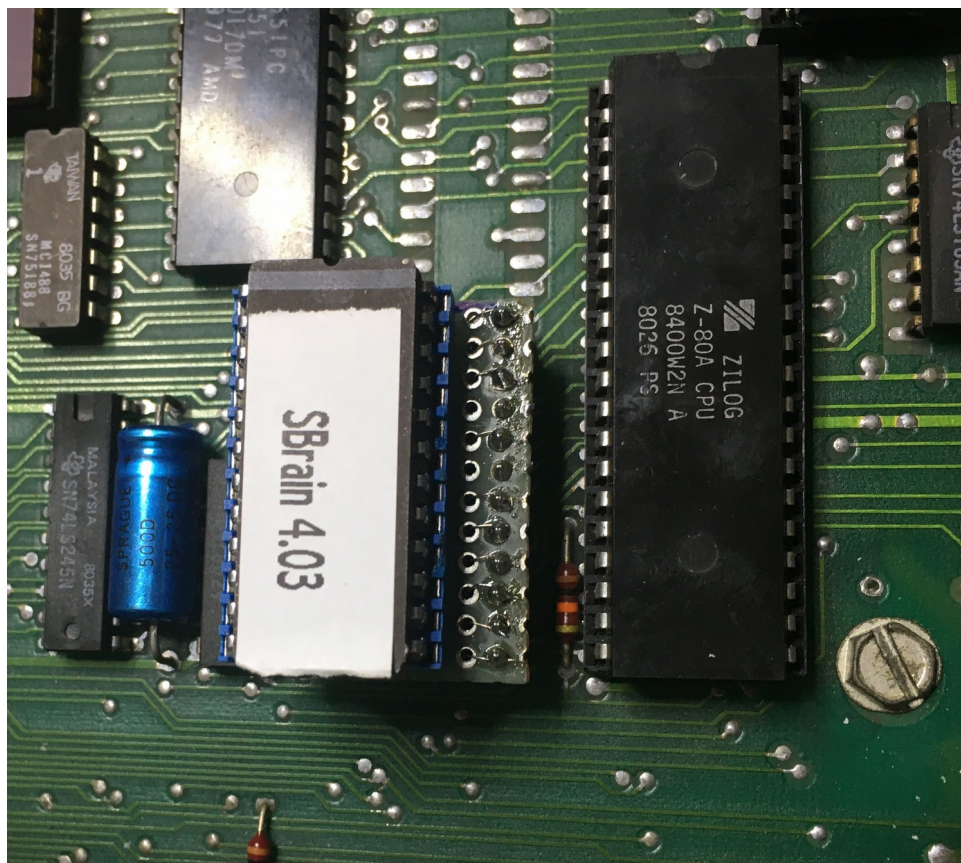
Sadly, while we were reassembling the machine, we discovered that the socket+adapter+eprom was too high and the case did not fit well anymore.

We decided to move backward to the "Italian" version of the firmware.

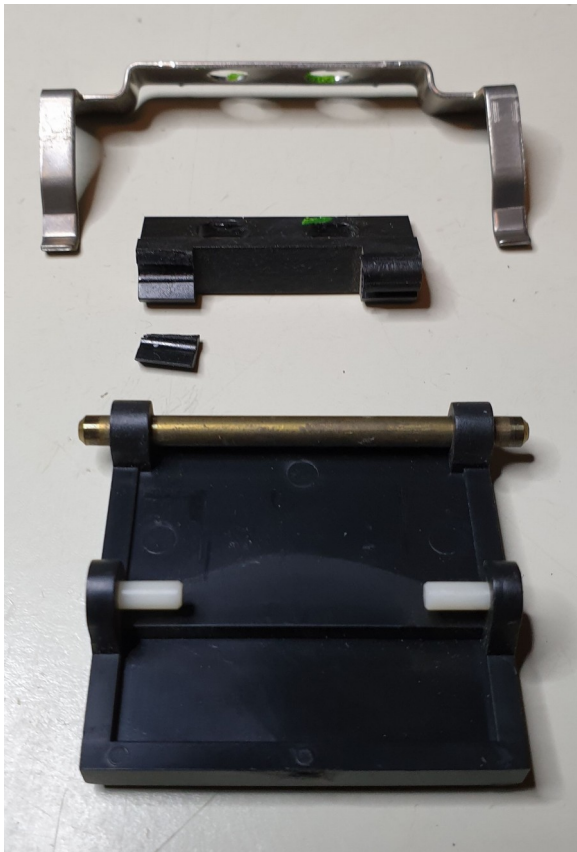
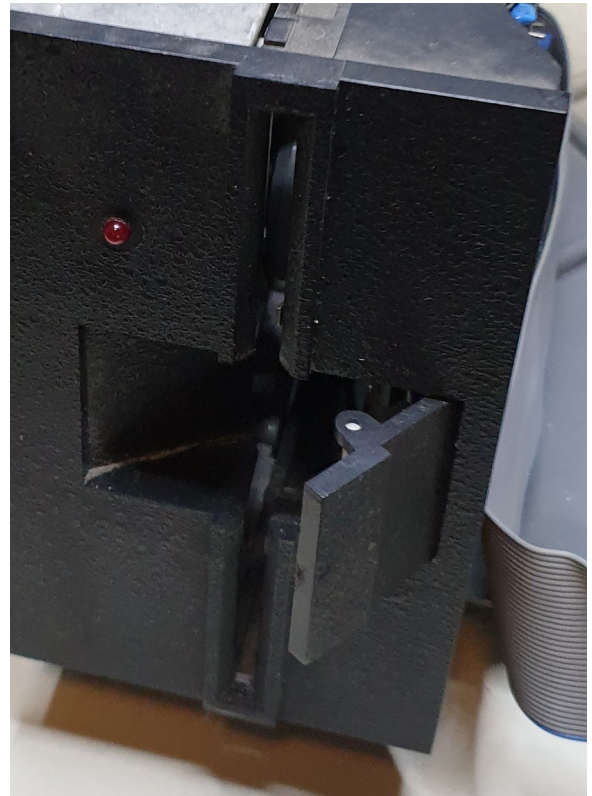
One of the floppy disk drives had the closing hook blocked in the close position; dismantling it we found that one of the plastic supports was broken.

Luckily we had a spare identical floppy drive in our spare parts warehouse. We had been able to fix it and the closing mechanism it's finally working perfectly.

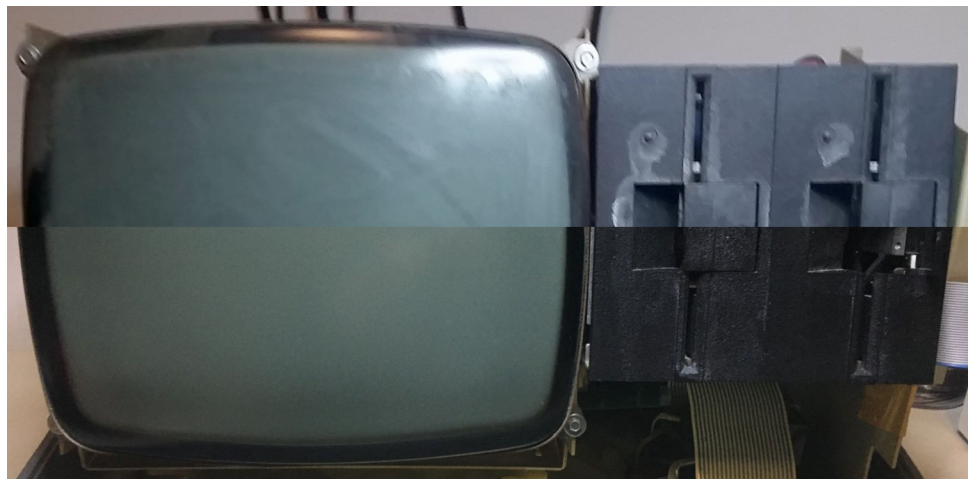
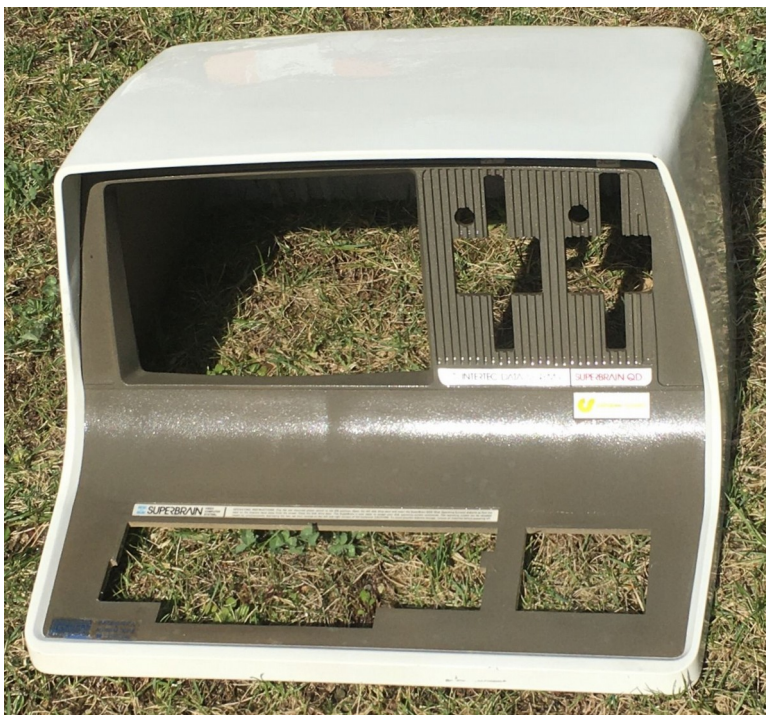
We spent a big effort in cleaning the Superbrain.

Luckily the computer has been built with strong materials, and we had been able to use a lot of water and soap outdoor for the case and a lot of other detergents on the other parts.

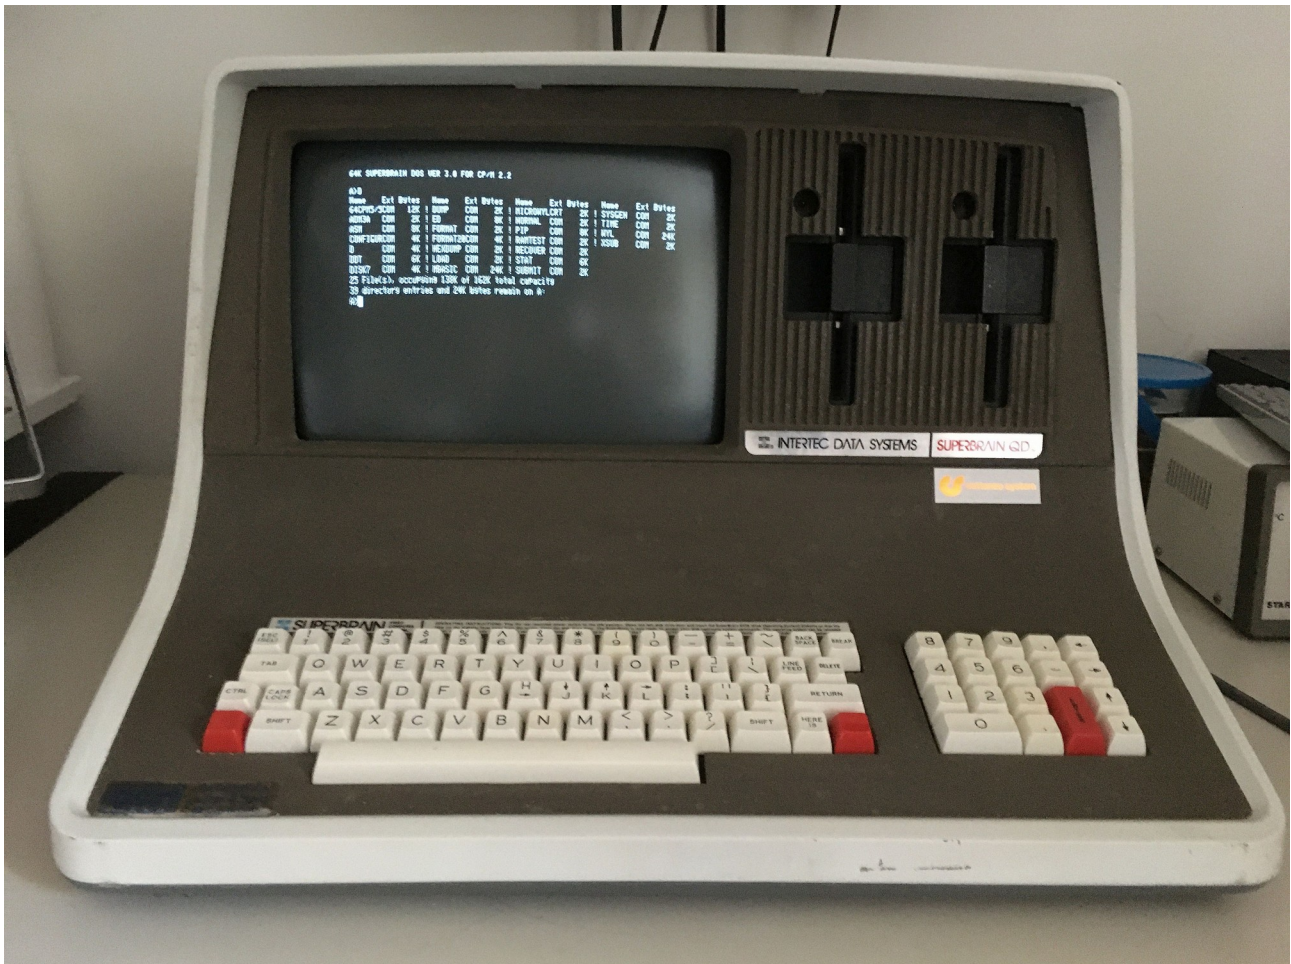
The machine now is working perfectly, time to boot the operating system and to run successfully some Cp/m programs.
